**ANALYSIS OF CORROSION POTENTIAL OF 1 ST FLOOR COLUMN
REINFORCEMENT IN RECTORATE BUILDING OF MUHAMMADIYAH
UNIVERSITY OF WEST SUMATERA**

ANALYSIS OF CORROSION POTENTIAL OF 1st FLOOR COLUMN REINFORCEMENT IN RECTORATE BUILDING OF MUHAMMADIYAH UNIVERSITY OF WEST SUMATERA

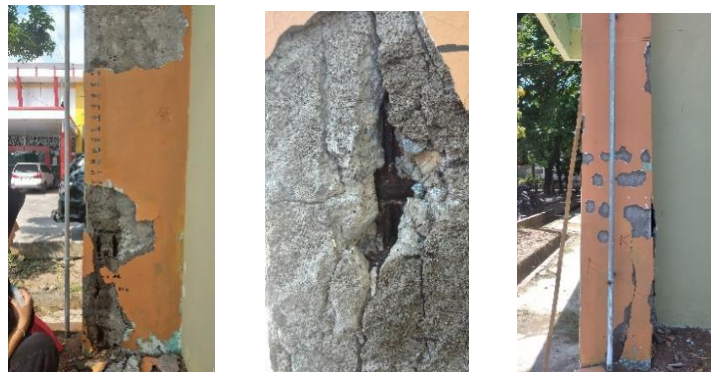
Pic 1 – Condition of the 1st-floor column of the Rectorate Building, Muhammadiyah University of Sumatera Barat (Personal documentation, 2024)

columns in the pedestal area have many cracks, so the concrete covers peel off. Exposed reinforcement is corroded due to exposure to seaside air at a distance of \pm 1 km from the building (Habirun et al., 2024).

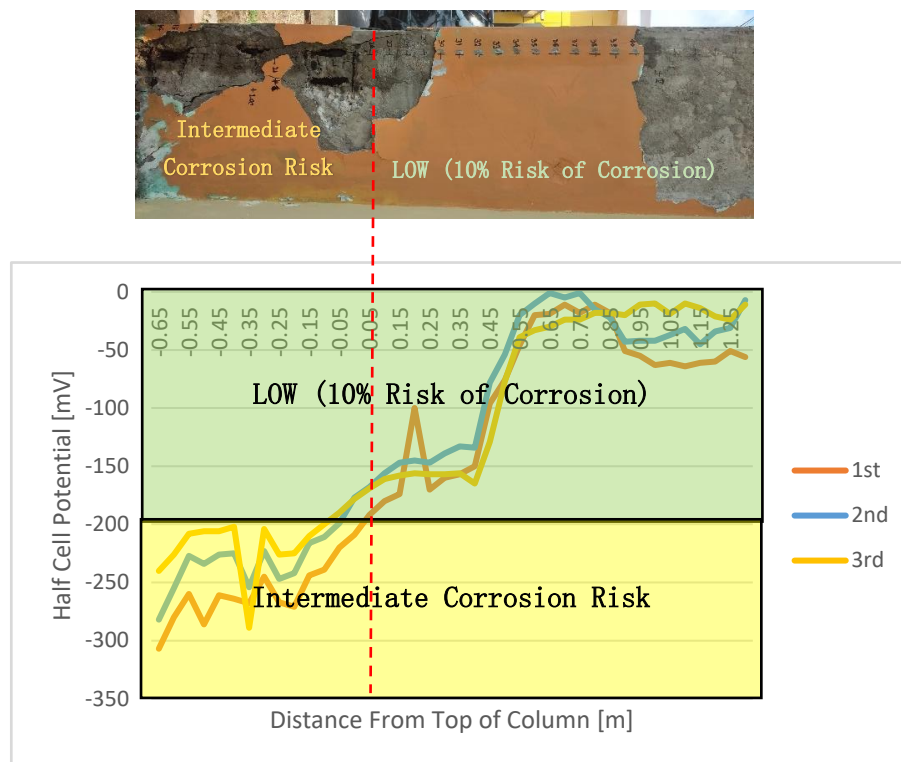
Pic 2. Half cell potential value of column reinforcement (2024)

Based on pic 2, the half cell potential test was carried out three times with a distance of 5 cm at each point. The red line shows the limit of medium and low corrosion, low corrosion has a value of ≥ -200 mV and for medium corrosion has a value of -200 mV to -350 mV.

Observations were made on the column support area that suffered severe damage such as cracks, peeled concrete, and corrosion of reinforcing steel. The corrosion potential of reinforcing steel is tabulated in Table 1. The corrosion potential value in pic 2 shows that the intermediate corrosion risk occurs at the bottom of the column from the point of exposure to reinforcement due to peeling off the concrete covers. Meanwhile, the risk of corrosion is low at the top of the column.
